TAMS 80100B PCI-VXI Controller

Installation & Operations Instructions

Installation & Operations Instructions for the TAMS 80100B PCI-VXI Controller

HP-UX Workstation and Linux Versions

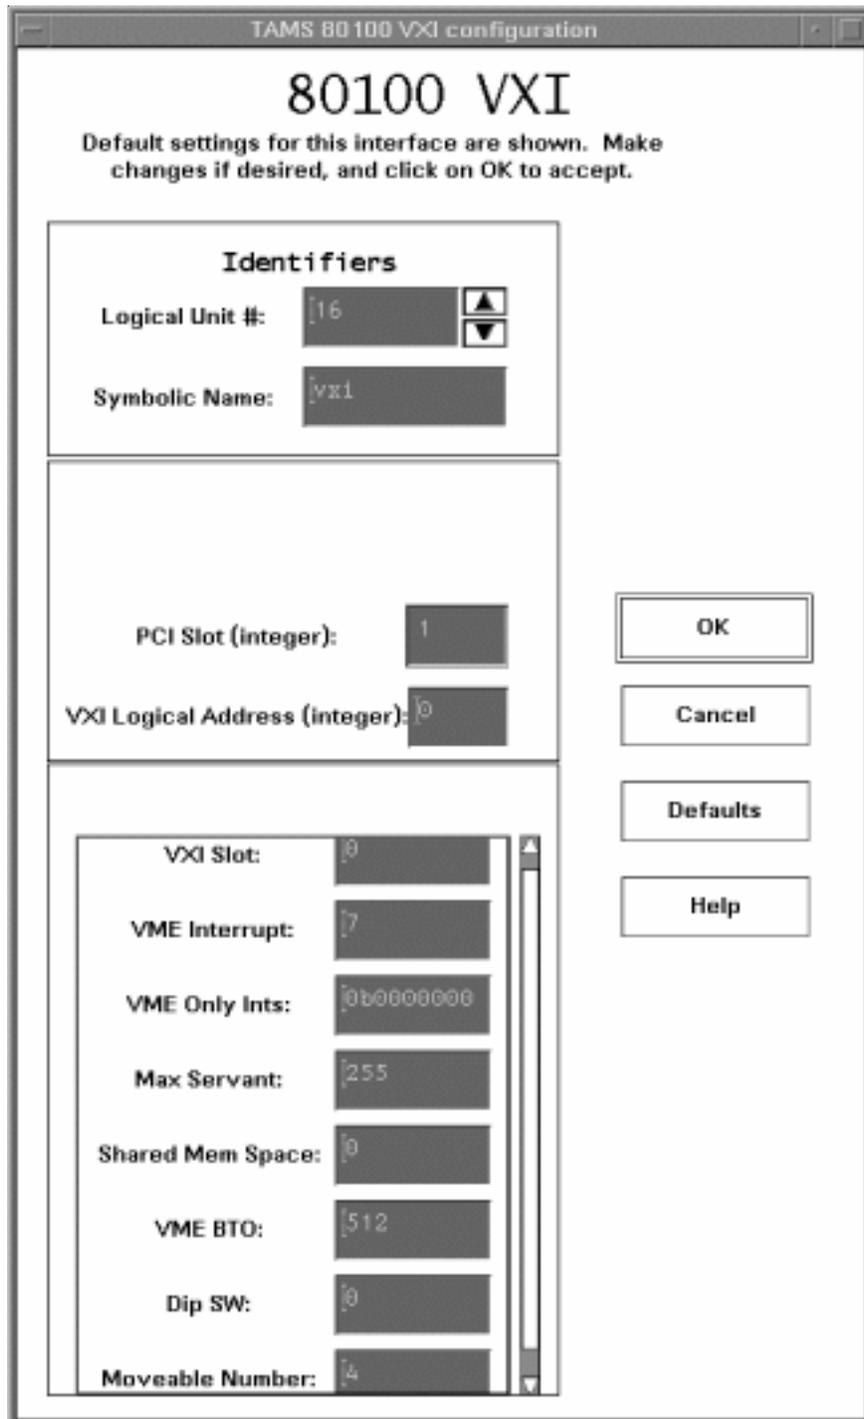
Figure 1. HP-UX 80100 configuration dialog with default values.

The 80100 can be configured with the *iosetup* configuration program. Figure 1 shows the configuration dialog with a typical configuration. To use *iosetup* on HP-UX:

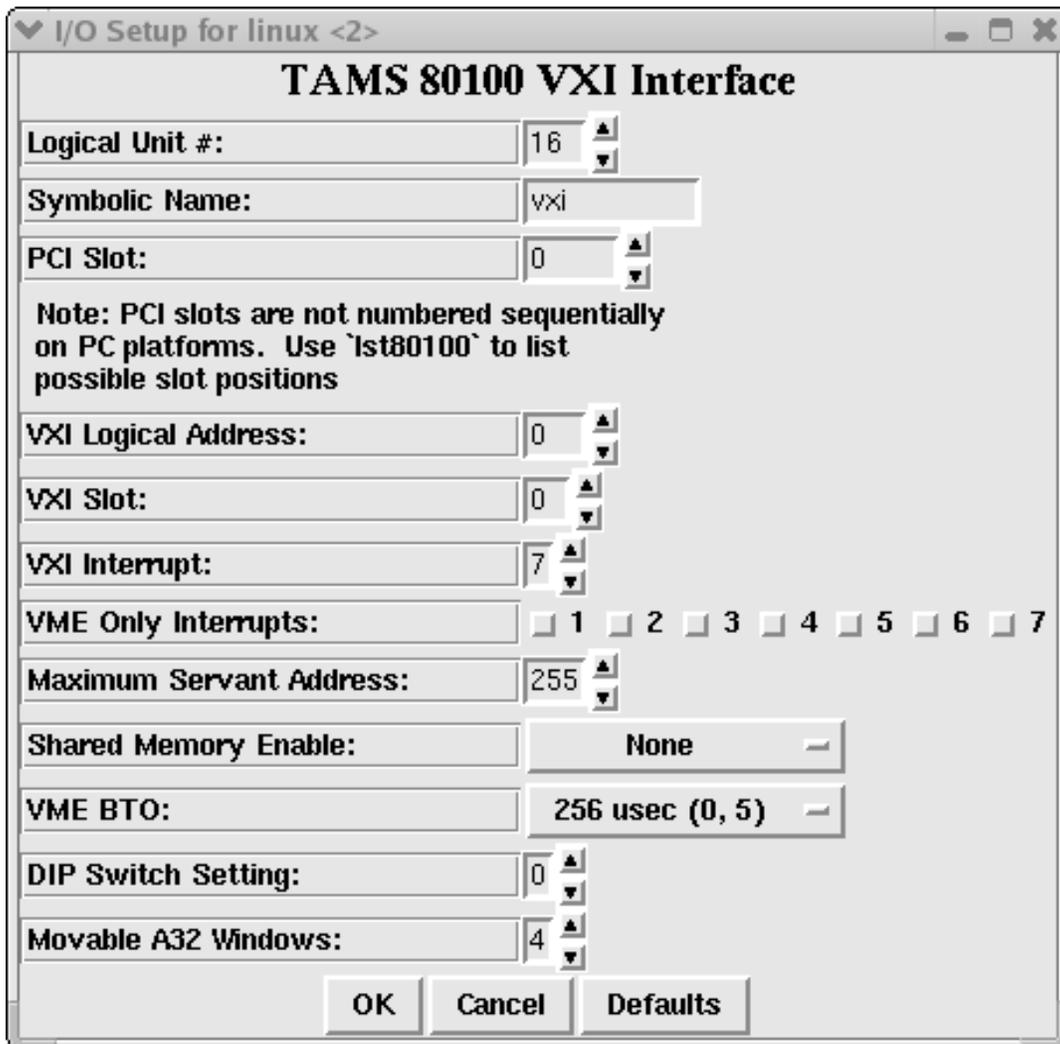
Figure 2. Linux 80100 configuration dialog with default values.

Figure 2 shows the configuration dialog on Linux with the default configuration. On Linux, configure the 80100 using *iosetup* as follows:
